# FATIGUE BEHAVIOUR OF A ROLLED AZ31 MAGNESIUM ALLOYS PREPARED BY EP AND BB CONDITIONS

**Abstract:** Rotating bending fatigue tests have been performed using smooth specimens of a rolled AZ31 magnesium alloy in laboratory air at ambient temperature. Fatigue strength and characteristic was evaluated and fracture mechanism was discussed on the basis fracture surface analysis. Electrical polishing (EP) as well as deep rolling (ball burnishing (BB)) U-notched specimens were performed on two groups of samples, to evaluate optimum conditions for fatigue life. The microstructure and tensile properties of roll cast (RC) Mg- 3% Al- 1% Zn (AZ31) was investigated. The fatigue strength of 107 cycles around 100 MPa for deep rolling while it was around 40 MPa for Electrical polishing. It was very important to understand the effect of (ball burnishing (BB)) conditions on the hardness of the surface through to the core. The two procedures improved the fatigue performance, but better improve in results were found in ball burnishing. The growth of small cracks initiated at the surface coincided with the FCP characteristic after allowing for crack closure for large cracks, but the operative fracture

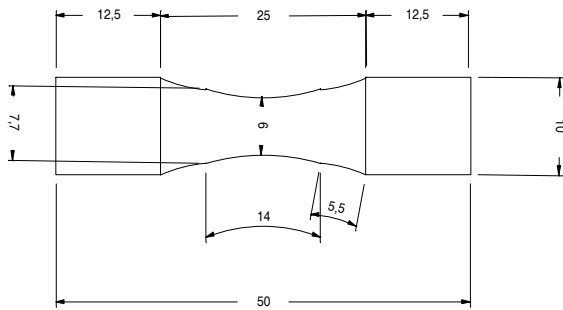
As shown in Fig. 1. Mechanical testing tensile and fatigue specimens with 5 mm diameter, 14 mm gauge length was machined from as-received so that their axis is parallel to the rolling direction. BB condition prepared with the following preparation condition on ECOROLL instrument using tool type (HG6) at 100 bar (246 N) with feed rate of 0.17 mm/min at 30 rpm.

**Fig. 1.** Shape and dimension of mechanical testing specimens

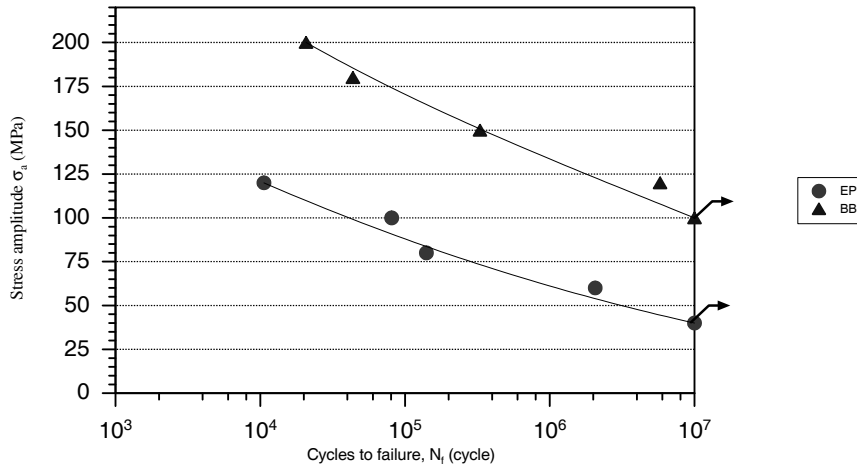
S/N curves for the EP and the BB specimens in laboratory at a stress ratio of -1 and frequency of 50 Hz (rolled magnesium alloy) in laboratory air is shown in Fig. 2. In this figure, for comparison purposes, the S–N curves of the EP and BB specimens are shown respectively. As seen from the figure, the fatigue life of the rolled magnesium alloy of EP specimen is relatively shorter than that of BB specimen. The extent bending in the S–N curve is gentler in the BB specimens than in the EP specimen. Next let us compare the S–N characteristics of the EP and BB specimens. There are great differences in the fatigue lives and in the fatigue limits, especially at higher stress amplitudes, there are differences in the fatigue lives.

Fig.2. S-N curve for rolled AZ31 at EP,BB conditions, rotating beam, R=-1, 50Hz.

4. Subsurface crack initiation occurred at applied stresses at 60 MPa. At BB condition but it can be seen for both 80 and 100 MPa stress for EP condition. The S-N diagram is shown in Fig. 2. It is well known that fatigue limit does not exist in non-ferrous alloys, thus fatigue tests were continued until  $10^7$  cycles. At EP condition  $\sigma = 40$  MPa, fatigue failure did not occur, but non-propagating cracks were observed on the specimen surface. As can be seen in the figure, the present Mg alloy seems to possess a definite fatigue limit, which may be related to the existence of non-propagating cracks. The fracture mode depending

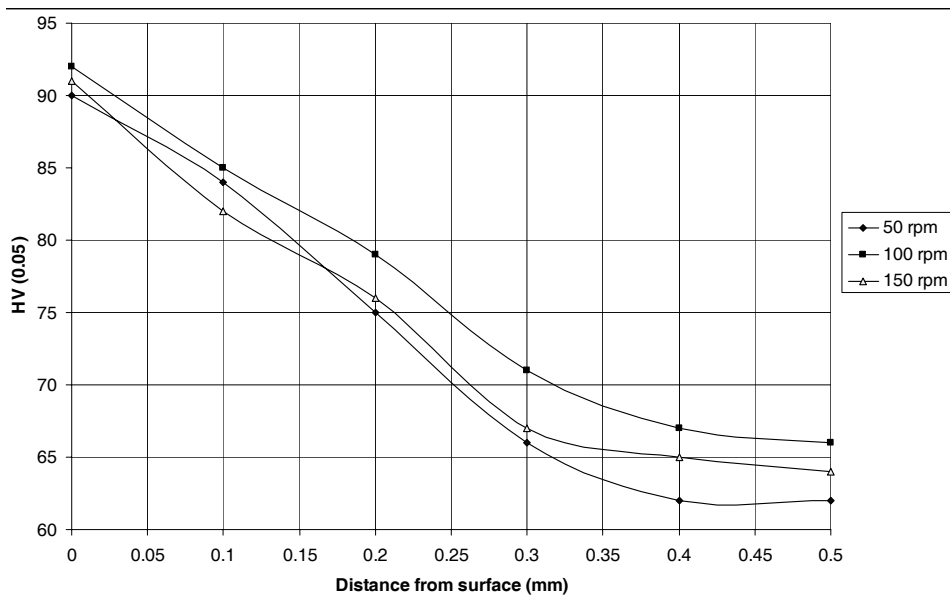
3. 3. A different experiment were used to investigate the best condition for BB (pressure, feed rate, speed) as example for tool HG3 200 bar (123 N) for 50, 100 and 150 rpm. The microhardness measurement from the surface in Fig. 3. Shows that the suitable condition for using 200 bars is 100 rpm for AZ31 as the hardness decreased from the circumference gradually to the center.

Fig. 3. Microhardness profile of AZ31 after BB at 200 bars, 0.17 mm/min at different BB rotation speed.

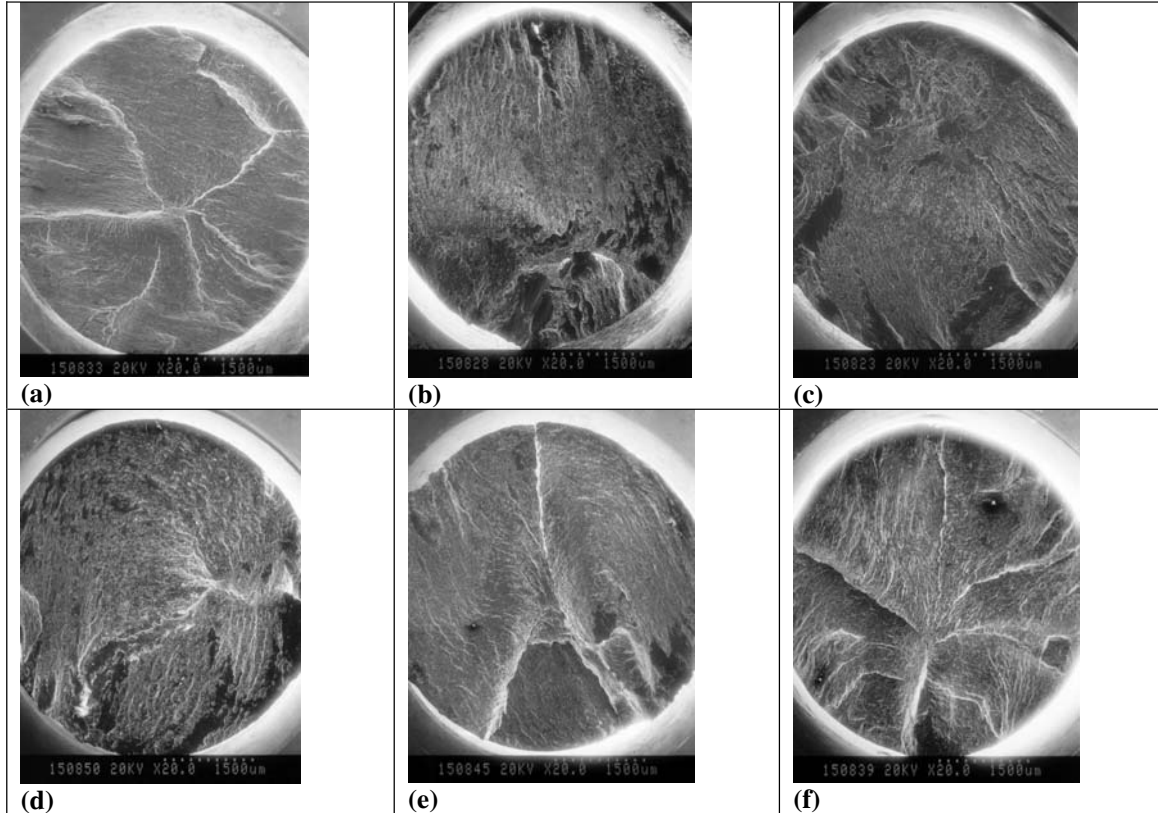
The fracture surface of AZ31 for EP condition and BB condition at different stress is shown in Fig.

**Fig.4.** SEM micrographs showing fracture surfaces at difference stress for EP at (a) 60MPa; (b) 80 MPa; (c) 100 MPa and BB at (d) 60MPa; (e) 80 MPa; (f) 100 MPa.

on applied stress level, above 60 MPa cracks initiate at the surface (surface fracture), while below that stress at the interior of the specimen (subsurface fracture). Subsurface fracture is a very interesting finding, which has not been recognized in Mg alloys, for both EP and BB conditions.

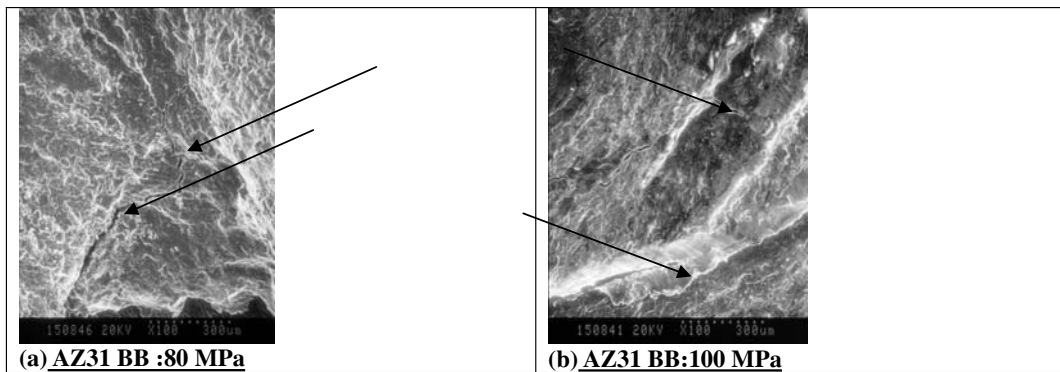
**Fig. 5.** SEM micrographs showing cracked surfaces at difference stress for BB at (a) 80MPa; (b) 100 MPa

The cracked line could be seen easily for higher stress for BB condition as fracture occurs in internal surface not at the outer surface as in the EP condition in Fig. 5.
